PREVENTATIVE MAINTENANCE

Iowa County Infra-structure value – GASB report 2011

Wisconsin adopted method of measuring pavement distresses through numerical ratings
PASER = Measuring tool

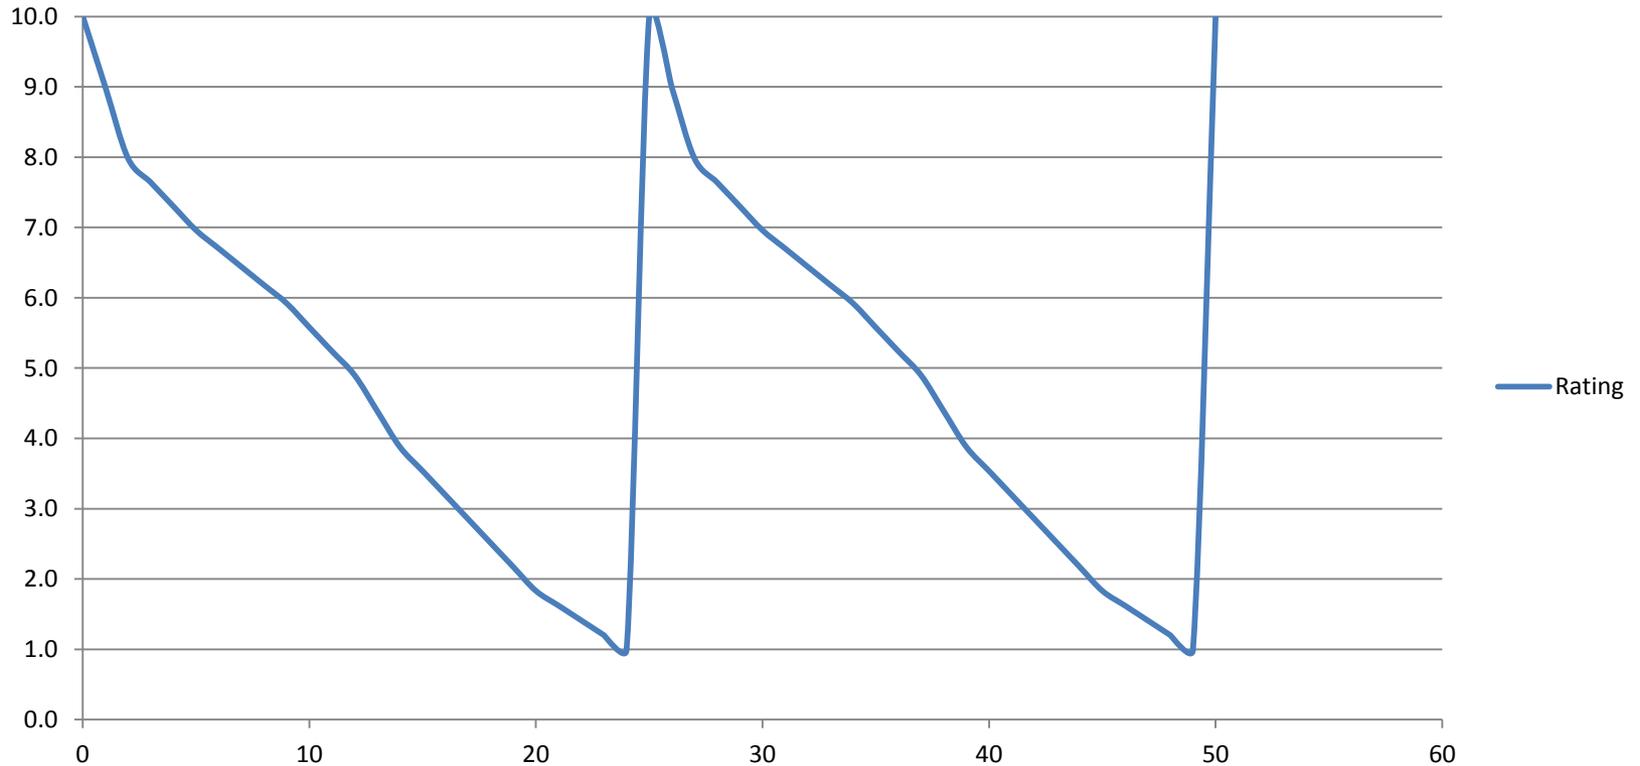
PASER Rating Vs Time (years)

PASER road rating mathematical procedure and assumptions based solely on asphalt pavement oil age and weathering deterioration

Serviceable road is considered a 4 or 5 rating and above.				
Paser Rating	Loss/Year	Years/Paser loss	Years	Treatment Recommendation
10	1.01	0.99	0	
9	1.01	0.99	0.99	
8	0.34	2.93	1.98	
7	0.26	3.85	4.91	Crackfill
6	0.341	2.93	8.76	Sealcoat
5	0.51	1.96	11.69	Seal and spot wedge restoration
4	<u>0.341</u>	<u>2.93</u>	<u>13.65</u>	<u>Sealcoat and other deterioration repairs</u>
3	0.341	2.93	16.58	Asphalt Pavement Resurface or Structural Overlay
2	0.21	4.76	19.51	Pavement & Subgrade Recondition or Rehabilitation
1	0.21	4.76	24.27	Complete Roadbed Reconstruction
0			29.03	Impassable – Closed to traffic

LIFE CYCLE OF AN ASPHALT PAVEMENT (Do Nothing Approach – Age Deterioration only)

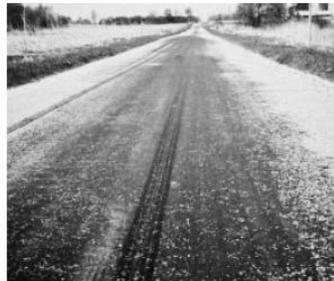
▶ Flushing. Dark patches show where asphalt has worked to surface.

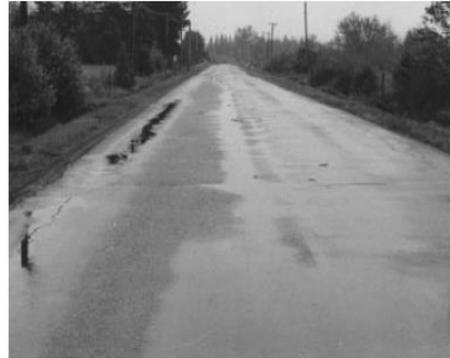
◀ Even slight rutting is evident after a rain.

Rutting is displacement of material, creating channels in wheelpaths. It is caused by traffic compaction or displacement of unstable material. Severe rutting (over 2") may be caused by base or subgrade consolidation. Repair minor rutting with overlays. Severe rutting requires milling the old surface or reconstructing the roadbed before resurfacing.

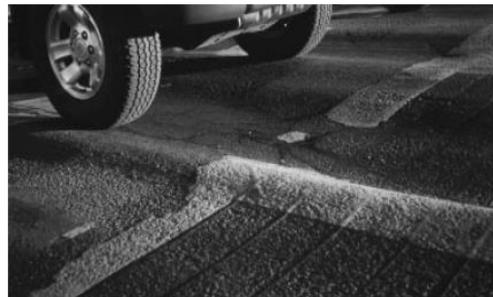
◀ Severe rutting over 2" caused by poor mix design.

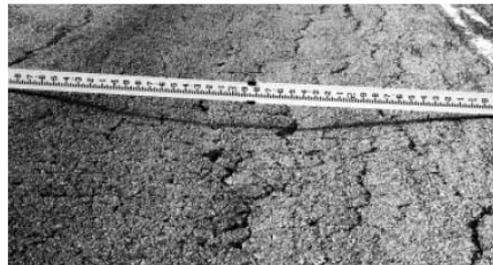
◀ Severe rutting caused by poor base or subgrade.

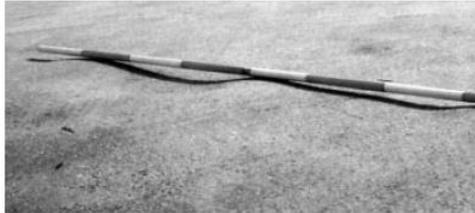
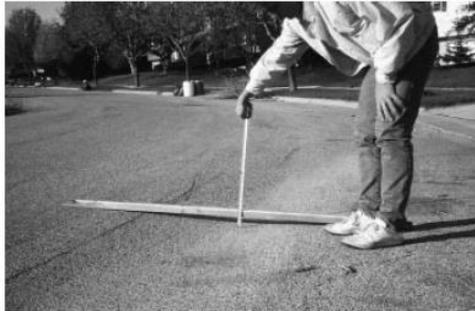
▼ Heavy traffic has shoved pavement into washboard ripples and bumps.

Showing or rippling is surfacing material displaced crossways to the direction of traffic. It can develop into washboarding when the asphalt mixture is unstable because of poor quality aggregate or improper mix design. Repair by milling smooth and overlaying with stable asphalt mix.

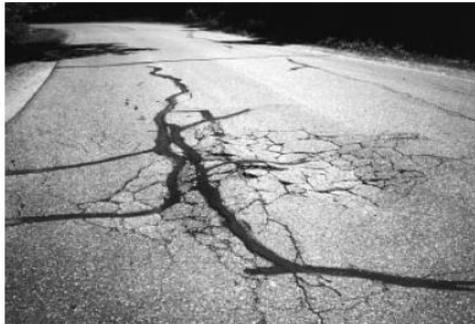
► Frost heave damage from spring break-up.

Other pavement distortions may be caused by settling, frost heave, etc. Patching may provide temporary repair. Permanent correction usually involves removal of unsuitable subgrade material and reconstruction.

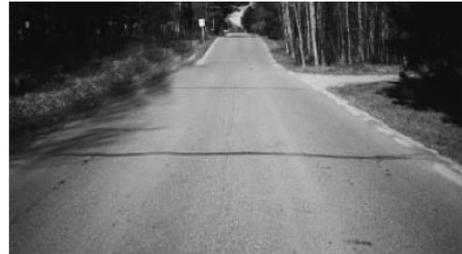
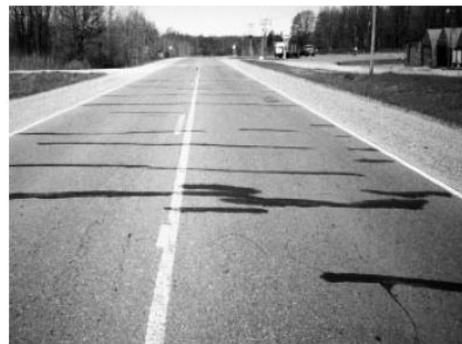
▼ Widely spaced, well-sealed cracks.

A crack at approximately right angles to the center line is a transverse crack. They are often regularly spaced. The cause is movement due to temperature changes and hardening of the asphalt with aging.

Prevent water intrusion and damage by sealing cracks which are more than 1/4" wide.

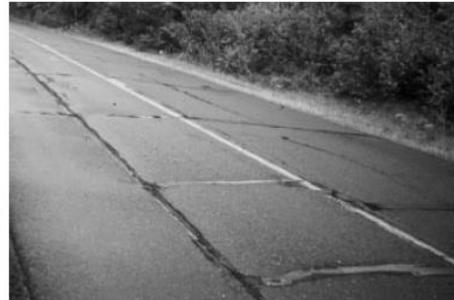
► Concrete joints reflected through bituminous overlay.

Cracks in overlays reflect the crack pattern in the pavement underneath. They are difficult to prevent and correct. Thick overlays or reconstruction is usually required.

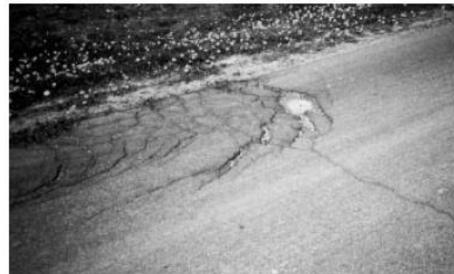
► Crescent-shaped cracks characteristic of slippage.

Crescent or rounded cracks in the direction of traffic, caused by slippage between an overlay and an underlying pavement. Slippage is most likely to occur at intersections where traffic is stopping and starting. Repair by removing the top surface and resurfacing using a tack coat.

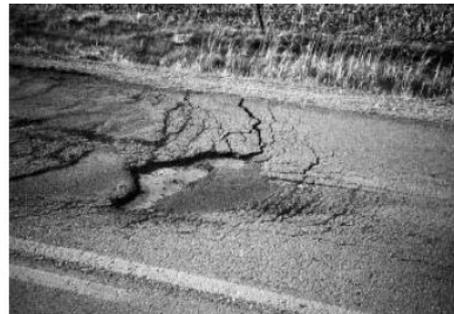
► Loss of bond between pavement layers allows traffic to break loose pieces of surface.

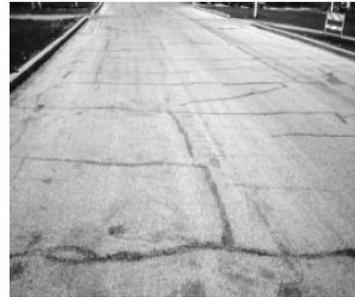
▶ Large blocks, approximately 10' across.

Block cracking is interconnected cracks forming large blocks. Cracks usually intersect at nearly right angles. Blocks may range from one foot to approximately 10' or more across. The closer spacing indicates more advanced aging caused by shrinking and hardening of the asphalt over time. Repair with sealcoating during early stages to reduce weathering of the asphalt. Overlay or reconstruction required in the advanced stages.

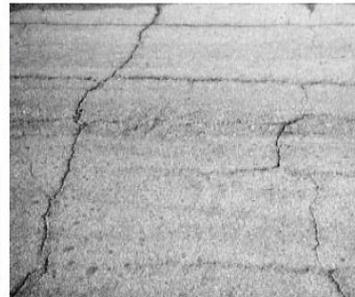
▶ Intermediate-size block cracking, 1'-5' across with open cracks.

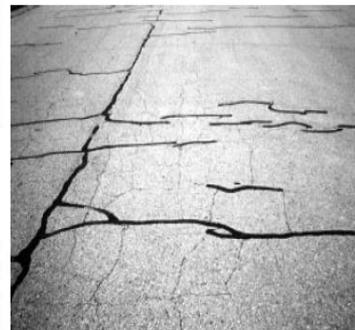
▶ Severe block cracking - 1' or smaller blocks. Tight cracks with no raveling.

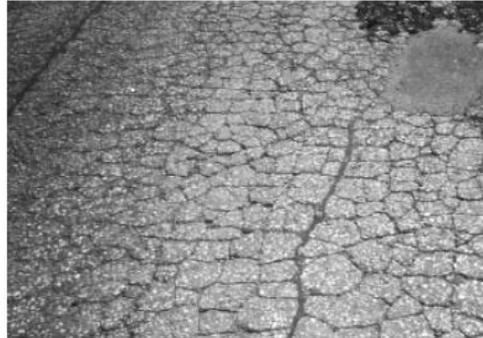
◀ Alligator crack pattern. Tight cracks and one patch.

Interconnected cracks forming small pieces ranging in size from about 1" to 6". This is caused by failure of the surfacing due to traffic loading (fatigue) and very often also due to inadequate base or subgrade support. Repair by excavating localized areas and replacing base and surface. Large areas require reconstruction. Improvements in drainage may often be required.

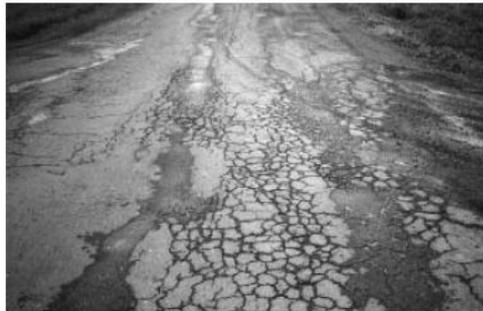
◀ Characteristic "chicken wire" crack pattern shows smaller pavement pieces and patching.

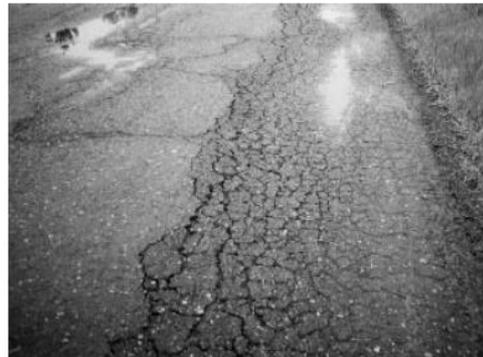
◀ Open raveled alligator cracking with settlement along lane edge most likely due to very soft subgrade.

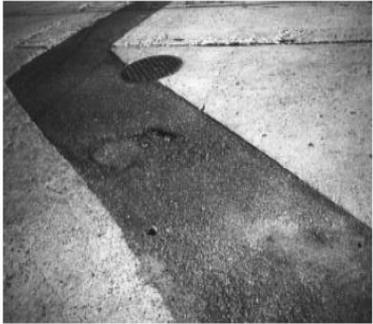
▶ Typical repair of utility excavation. Patch in fair to good condition.

Original surface repaired with new asphalt patch material. This indicates a pavement defect or utility excavation which has been repaired. Patches with cracking, settlement or distortions indicate underlying causes still remain. Recycling or reconstruction are required when extensive patching shows distress.

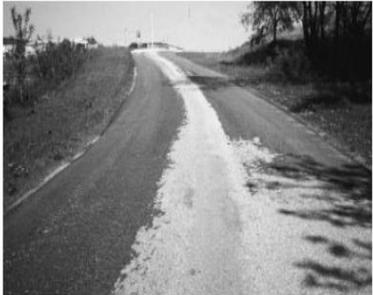
▶ Edge wedging. Pavement edges strengthened with wedges of asphalt. Patch is in very good condition.

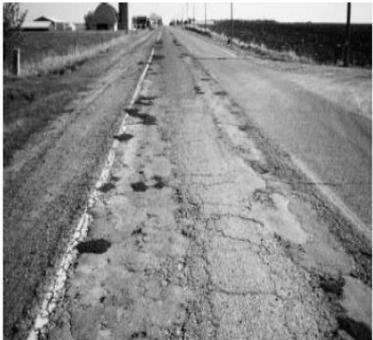
▶ Extensive patching in very poor condition.

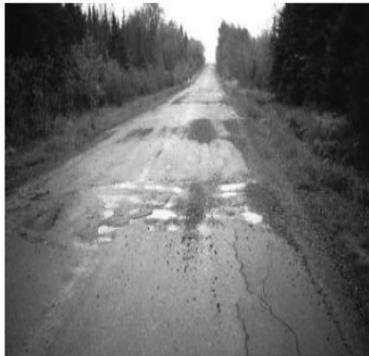
◀ Multiple potholes show pavement failure, probably due to poor subgrade soils, frost heave, and bad drainage.

Holes and loss of pavement material caused by traffic loading, fatigue and inadequate strength. Often combined with poor drainage. Repair by excavating or rebuilding localized potholes. Reconstruction required for extensive defects.

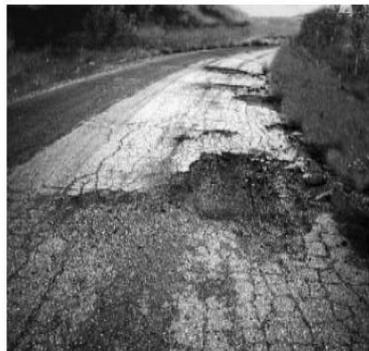
◀ Large, isolated pothole, extends through base. Note adjacent alligator cracks which commonly deteriorate into potholes.

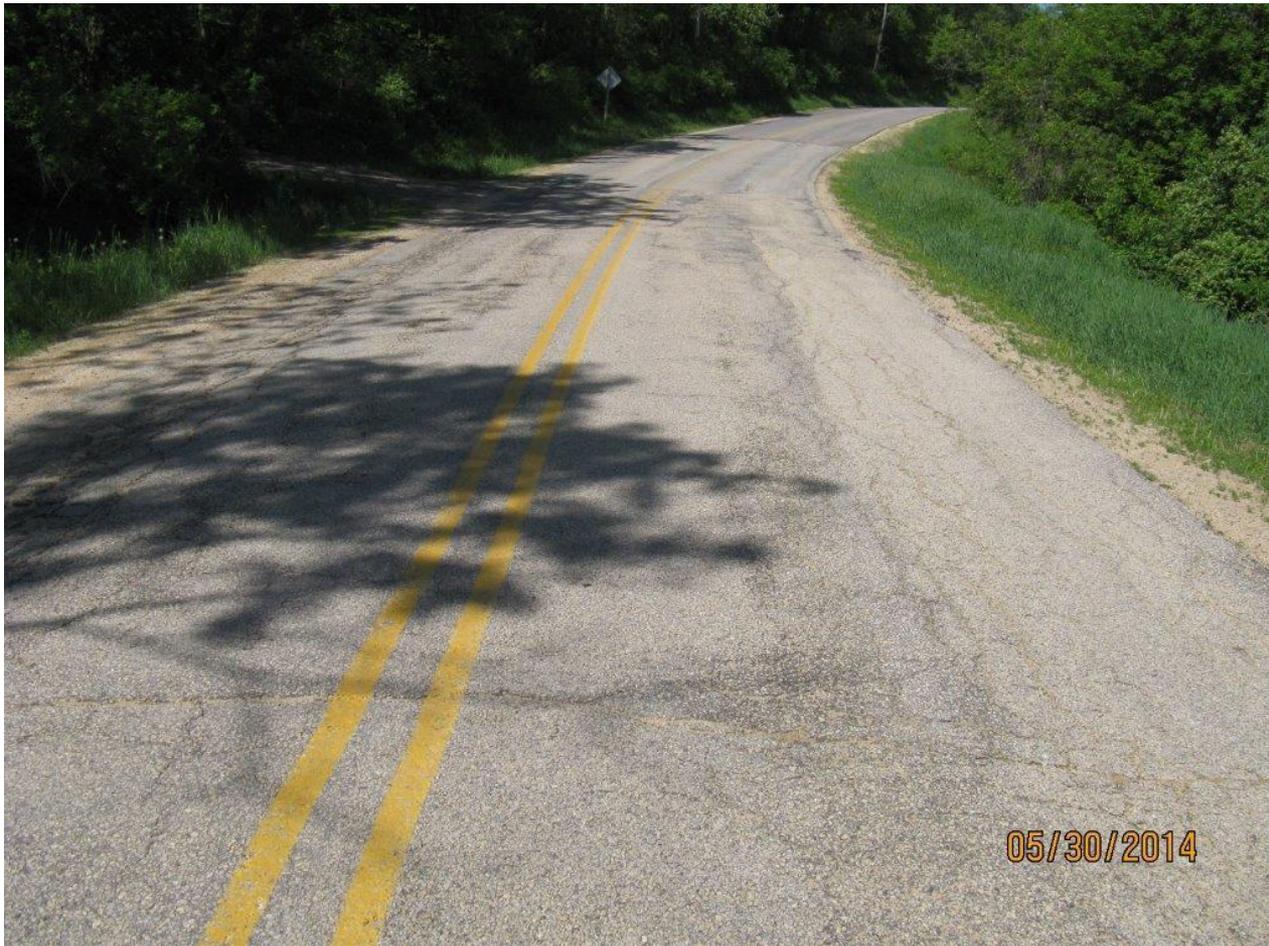
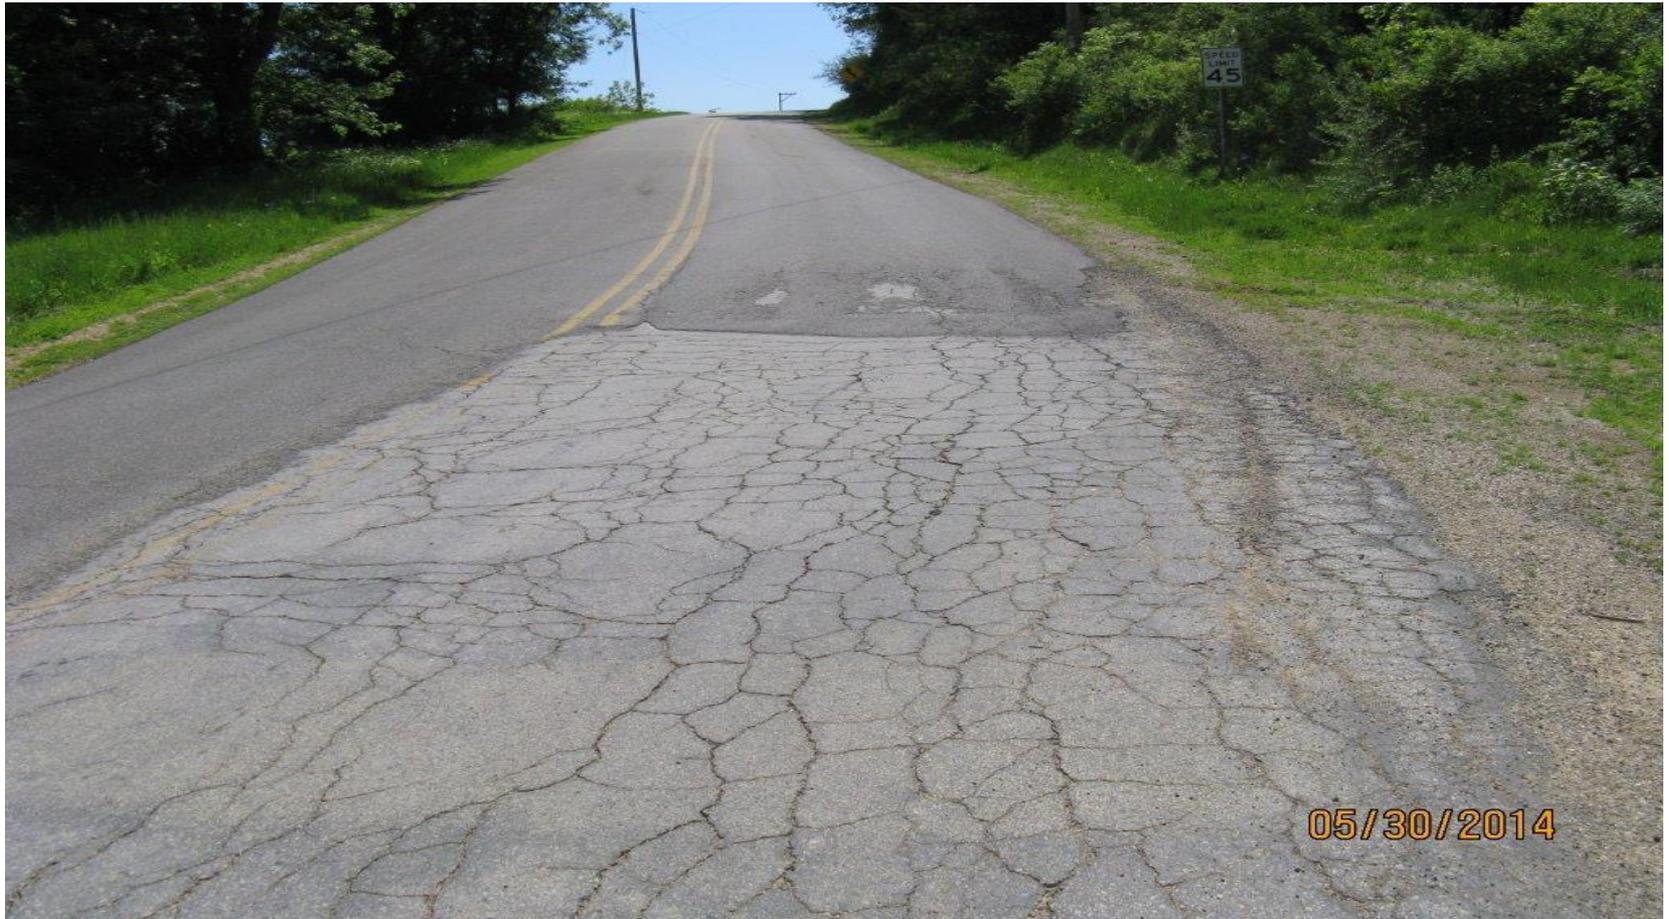
PASER 1 = CTH F OR T (BIRCH LK)

PASER 1 THRU 3 DEPENDING ON

- FREQUENCY OF BLOCK CRACK SPACING (Size of Blocks or Alligators)
- SEVERITY OF PAVEMENT DEFORMATION (Amount of rutting)
- SUBGRADE CONDITION (Pumping of pavement and soils)
- TRAFFIC VOLUME AND TYPE (Functional capacity can contribute to structural deficiency due to load and frequency)

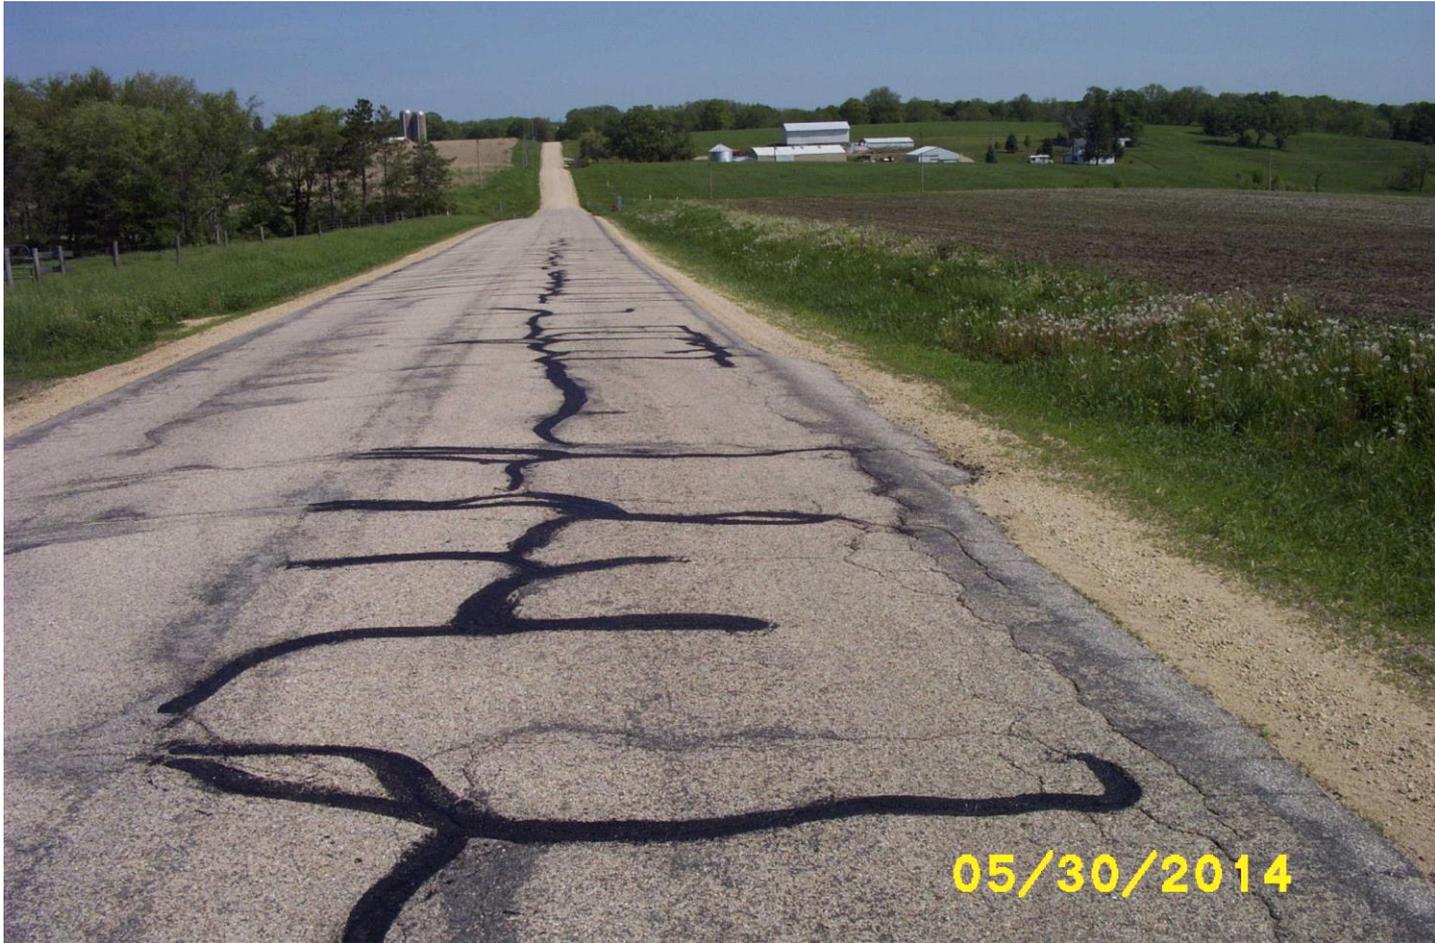
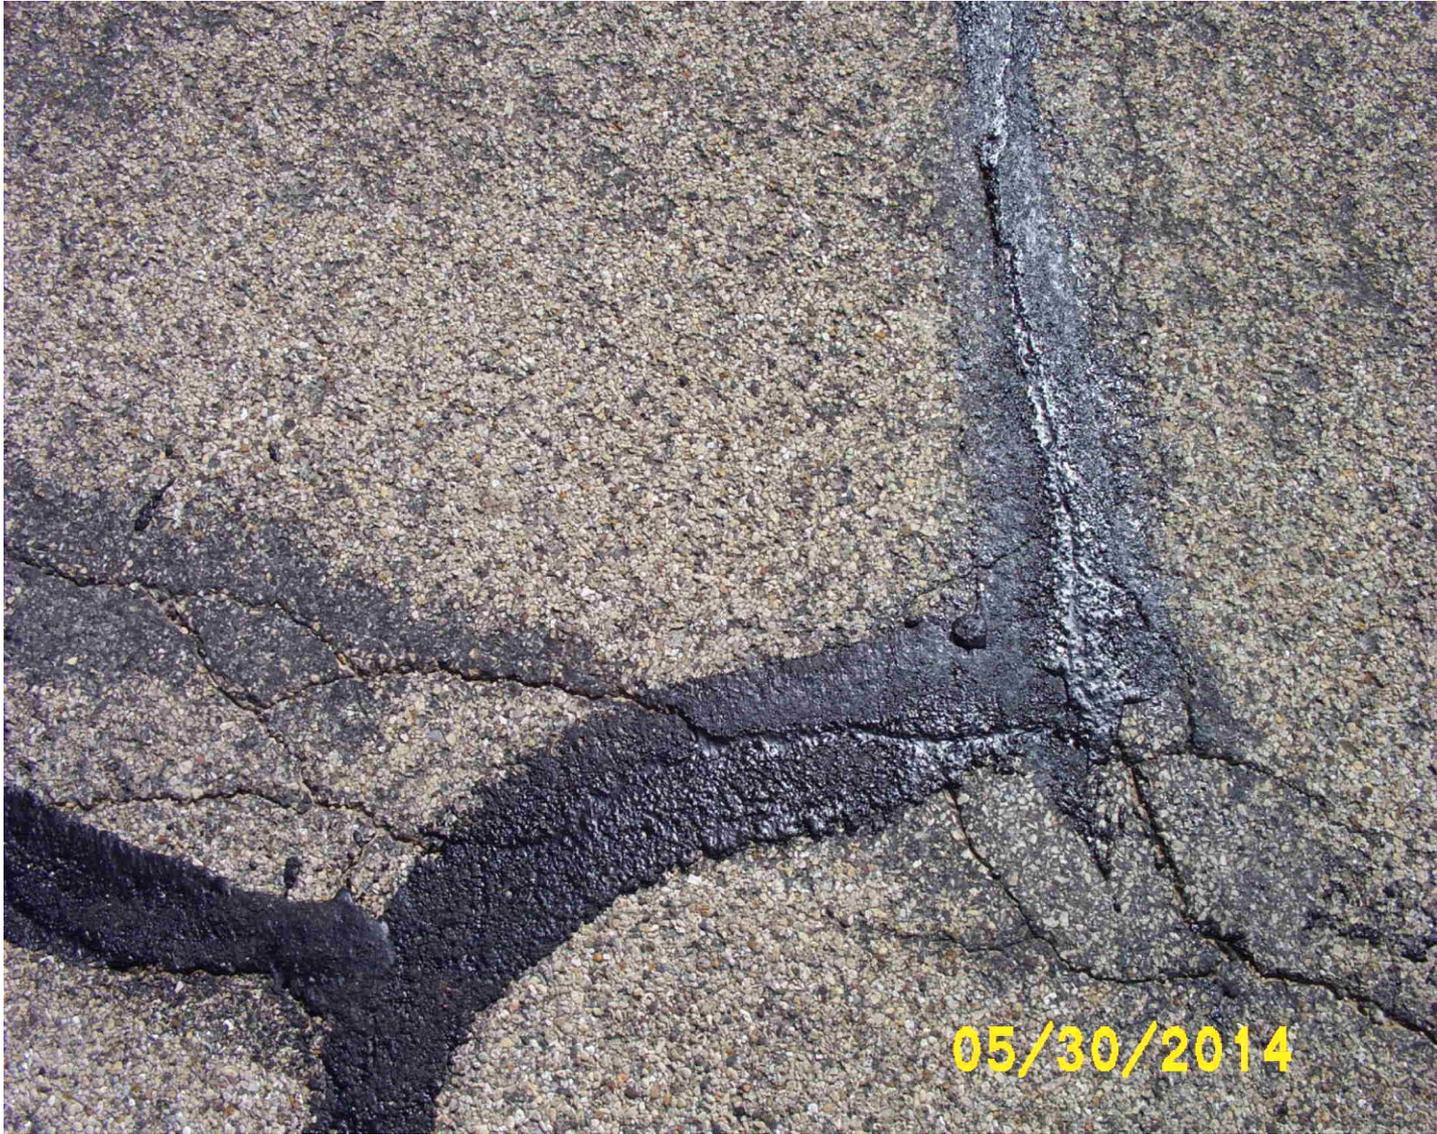
Overband – CTH D

- Overband Crackfilling – Crack cleaning and filling treatment of the pavement surface longitudinal and some transverse joints.
 - **Crackfill** – Crack rout, cleaning, and filling treatment of transverse and some longitudinal joints.

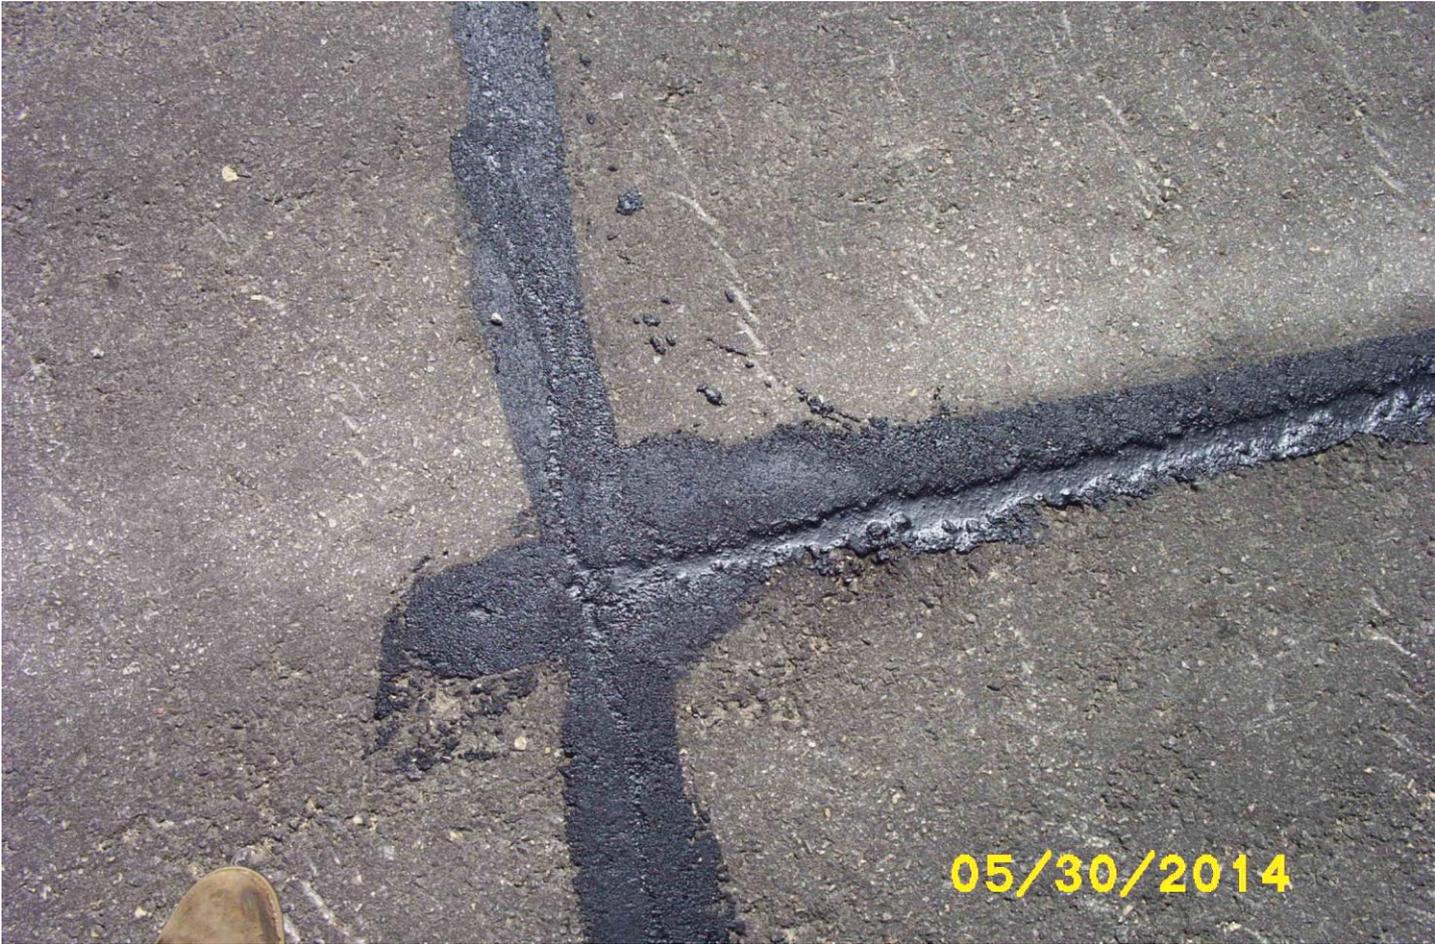
Overband (Left) versus Rout-N-Seal (Right) Crackfill example – CTH D

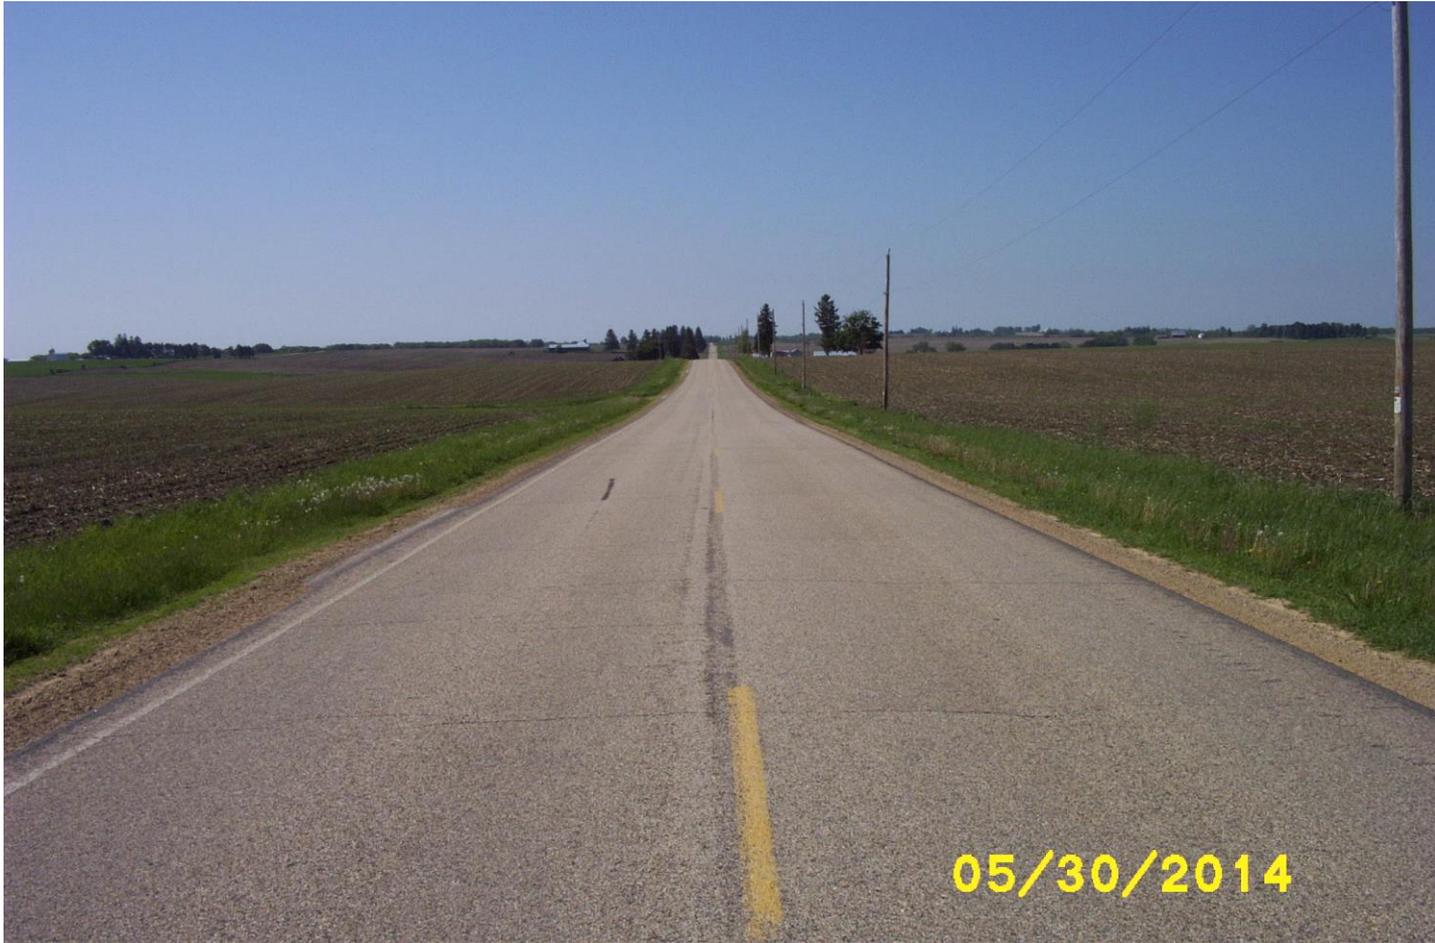
Chip Seal (Sealcoat) – CTH Q

- Fog Sealing – Oil treatment of the pavement surface.
 - Micro-surfacing – single or multiple layers of thin aggregate (< ¼”) overlays.
 - **Chip seal** – single or double layers of aggregate (1/4” to 3/8”).

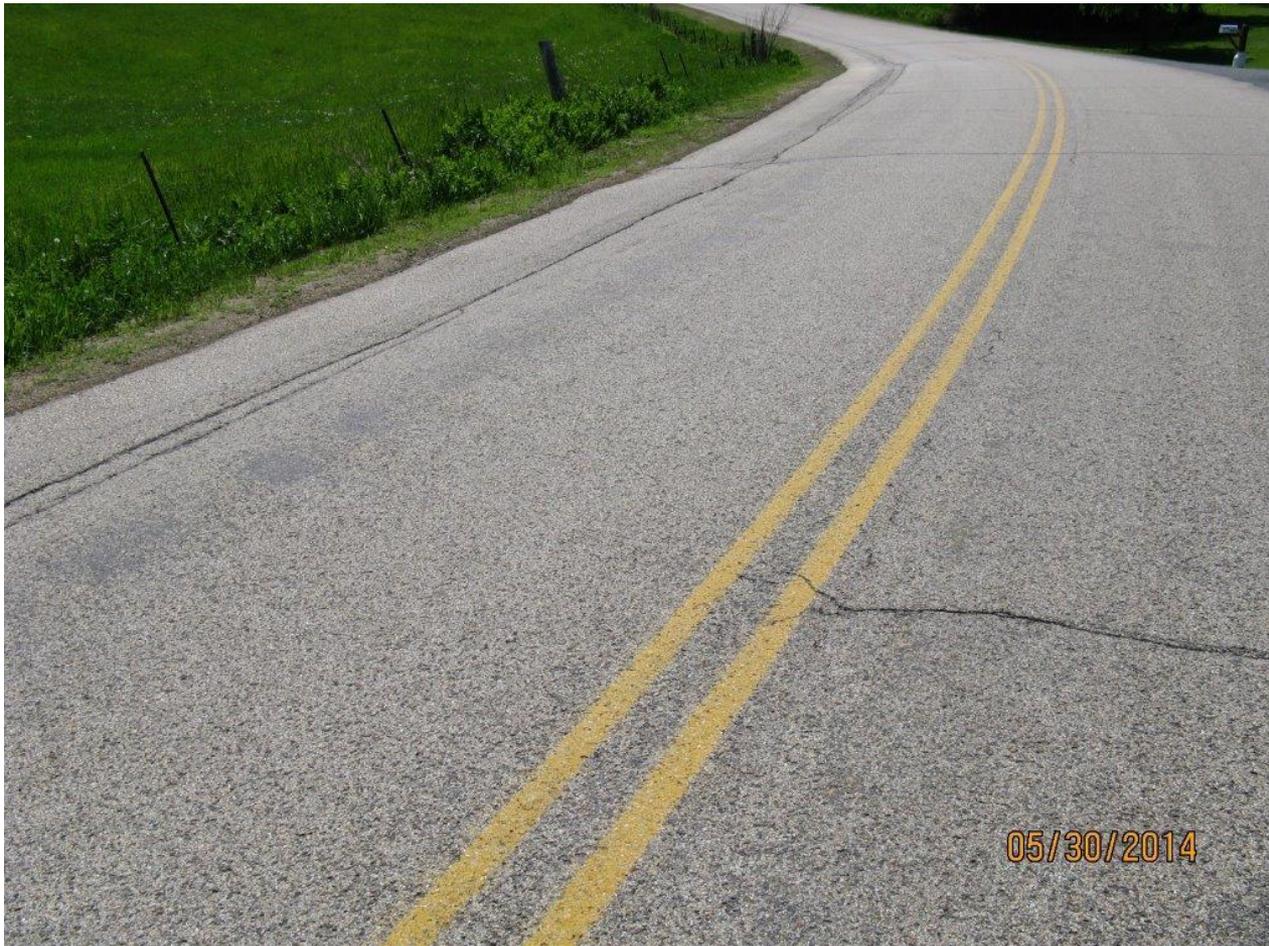
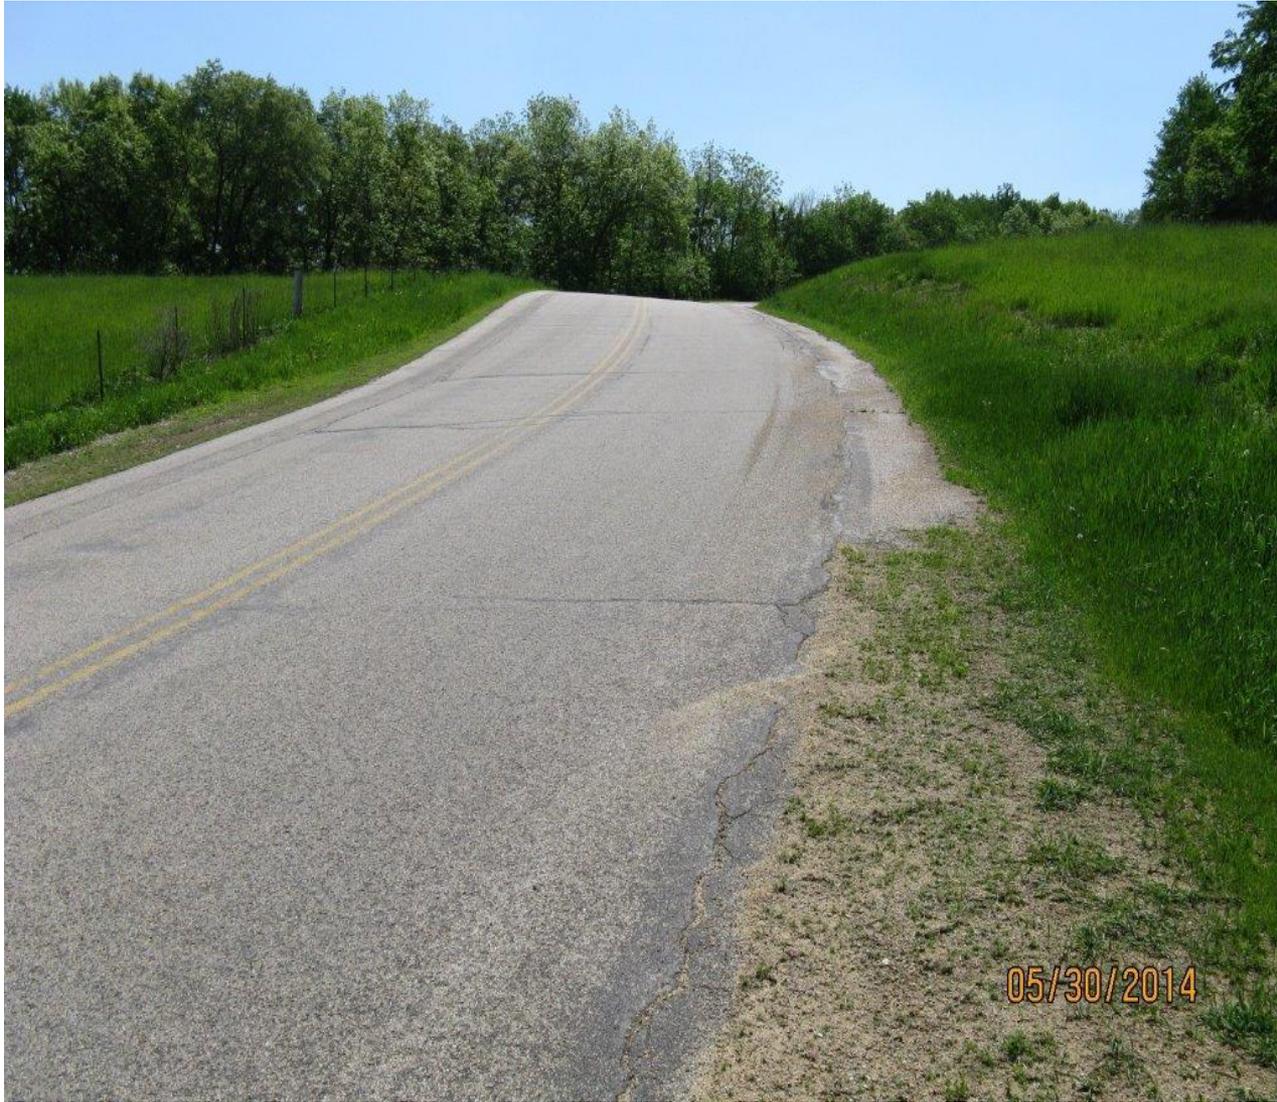
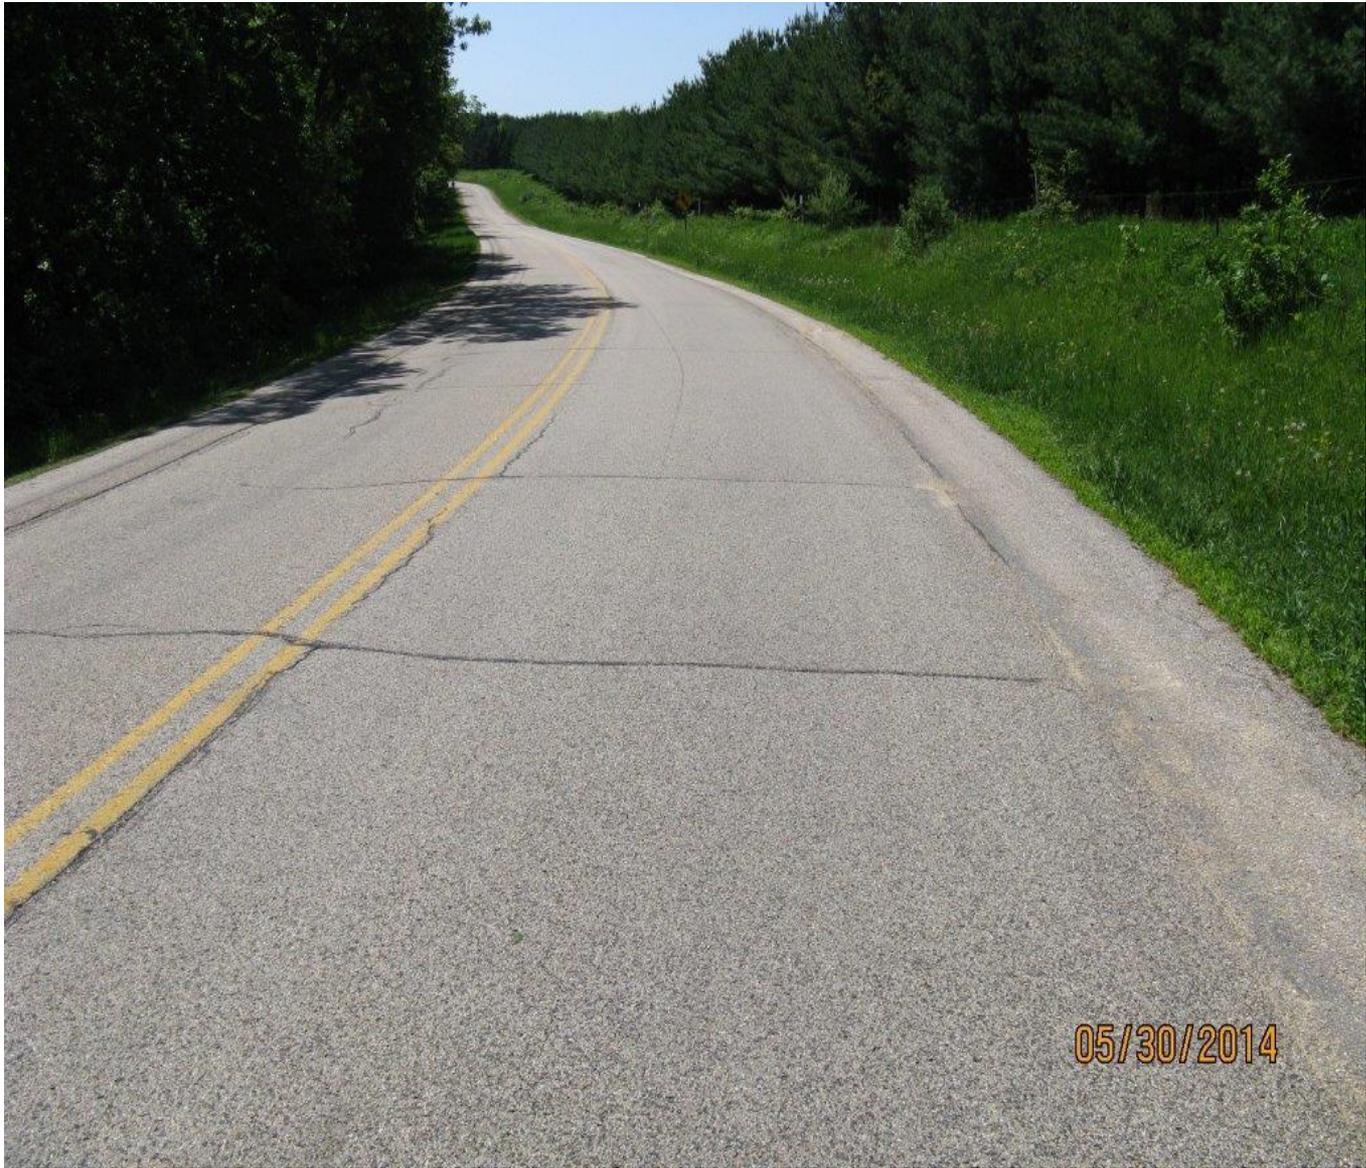
HMA Shoulder Ribbon – CTH H

- **HMA Shoulder Ribbon** – asphalt shoulder placement for drainage or load widening.
 - **Ultra-thin HMA Overlay** – overlays of 1” thickness or less.

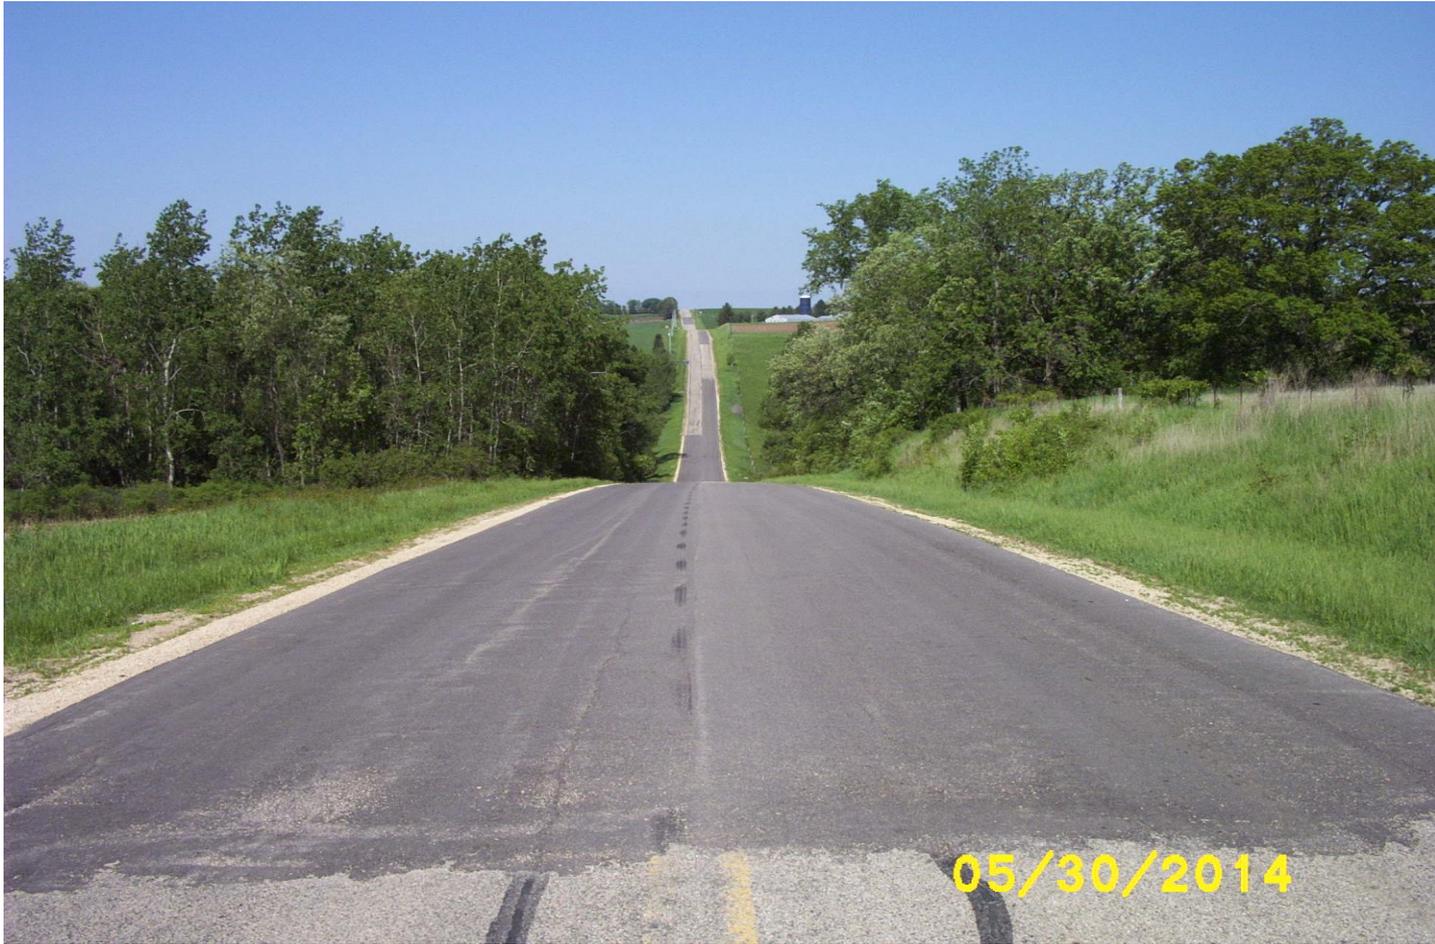
HMA Wedge and Sealcoat

- **HMA Wedge and Sealcoat** – HMA pavement placement in deficiency areas then a sealcoat surface.
 - Paver placed Surface Seal – ultrathin overlay with emulsifier sealant.

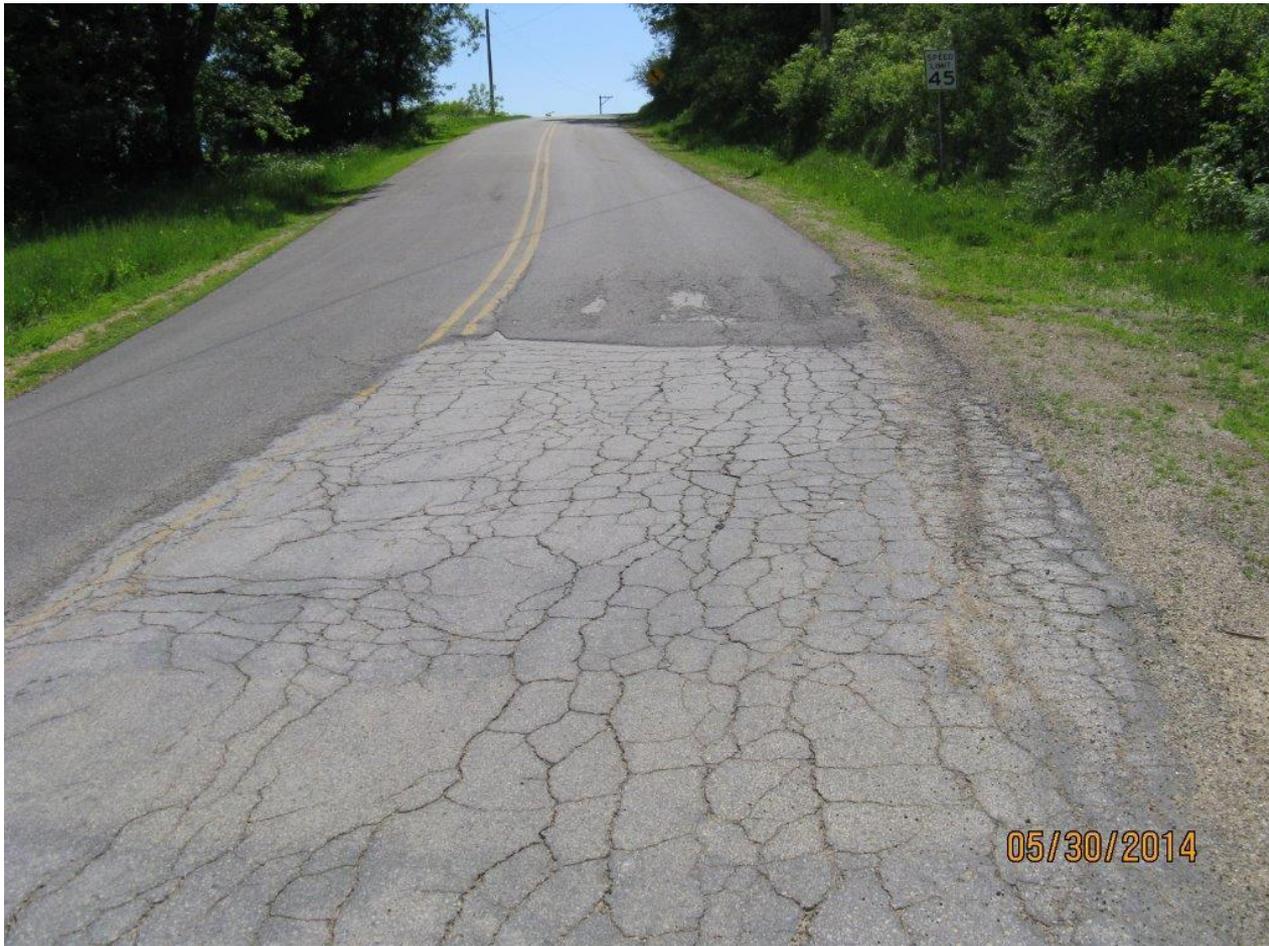
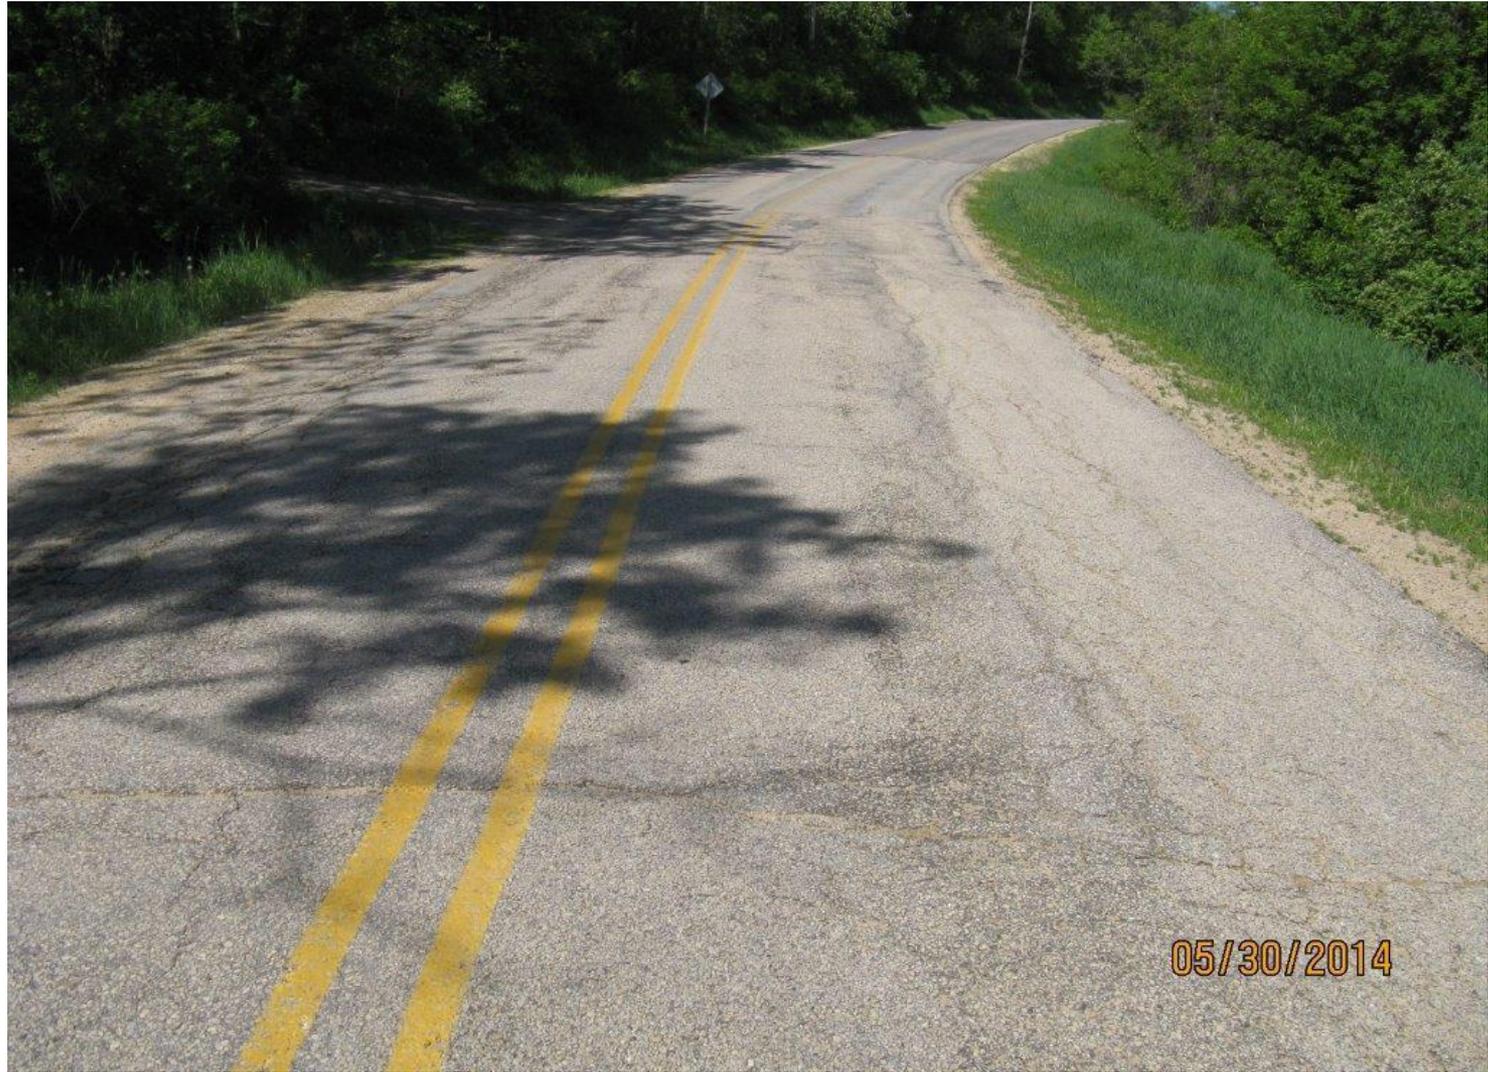
Non-structural Overlay

- **Non-structural HMA Overlay** – overlays of less than 2” thickness.
