PREVENTATIVE MAINTENANCE

Iowa County Infra-structure value – GASB report 2011

Wisconsin adopted method of measuring pavement distresses through numerical ratings
PASER = Measuring tool

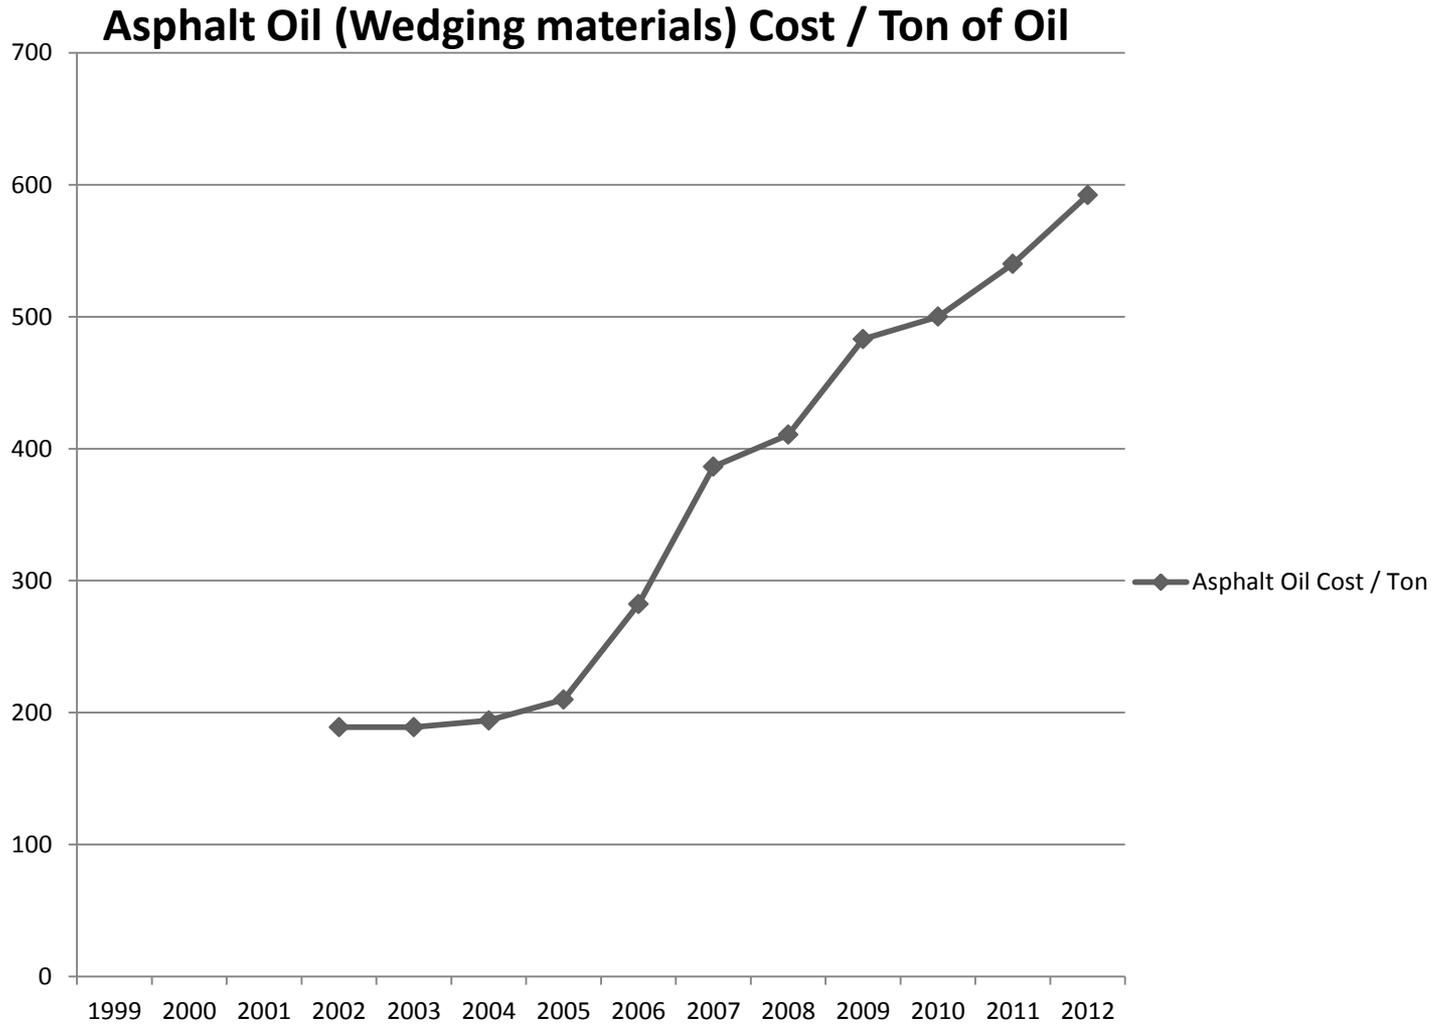
In 1999 wedging costs were \$27.00/ton; in 2012 costs were \$43.00/ton

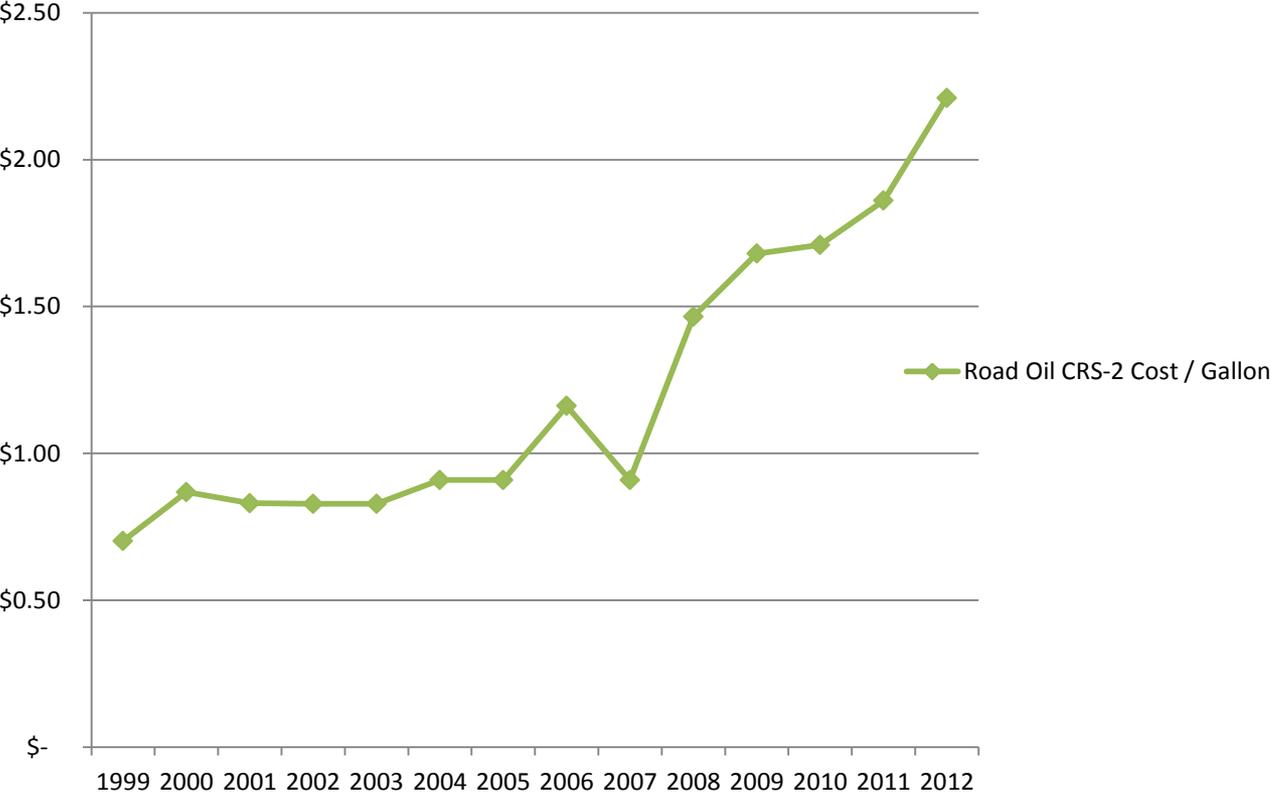
Road Oil (Sealcoat oils) CRS-2 Cost / Gallon

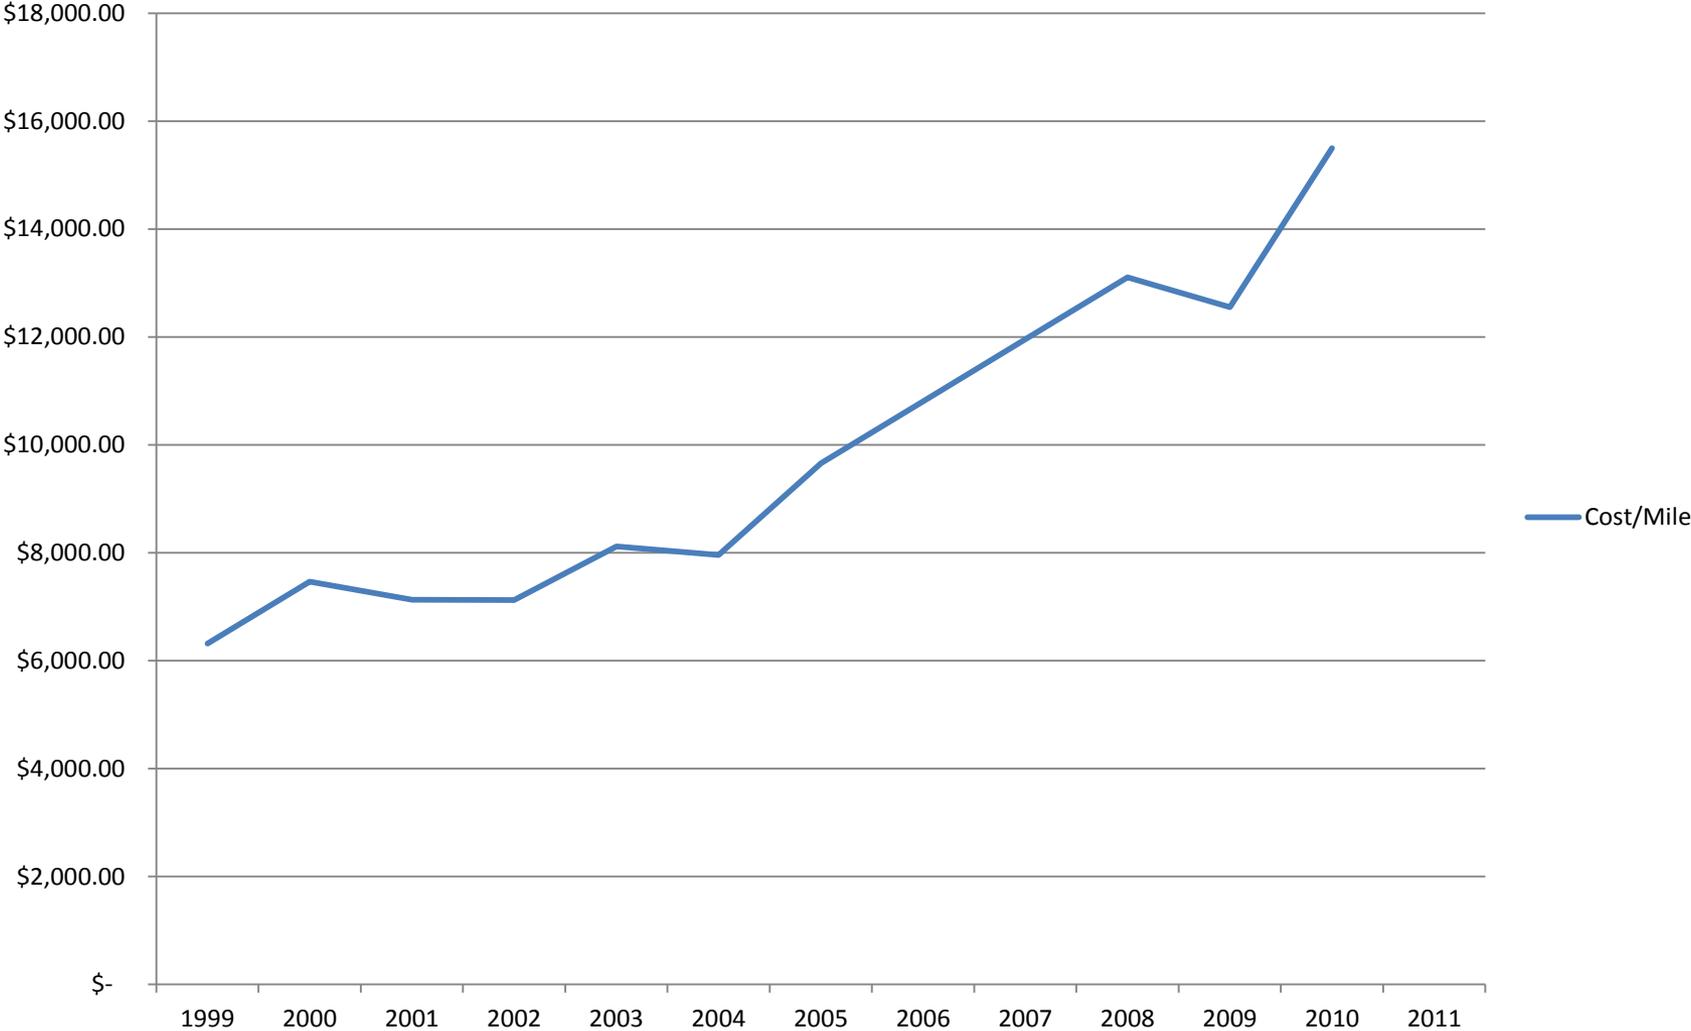
In 1999 a sealcoat was \$6,314/mile; 2012 a sealcoat was \$13,868/mile

Sealcoat surface treatment Cost/Mile

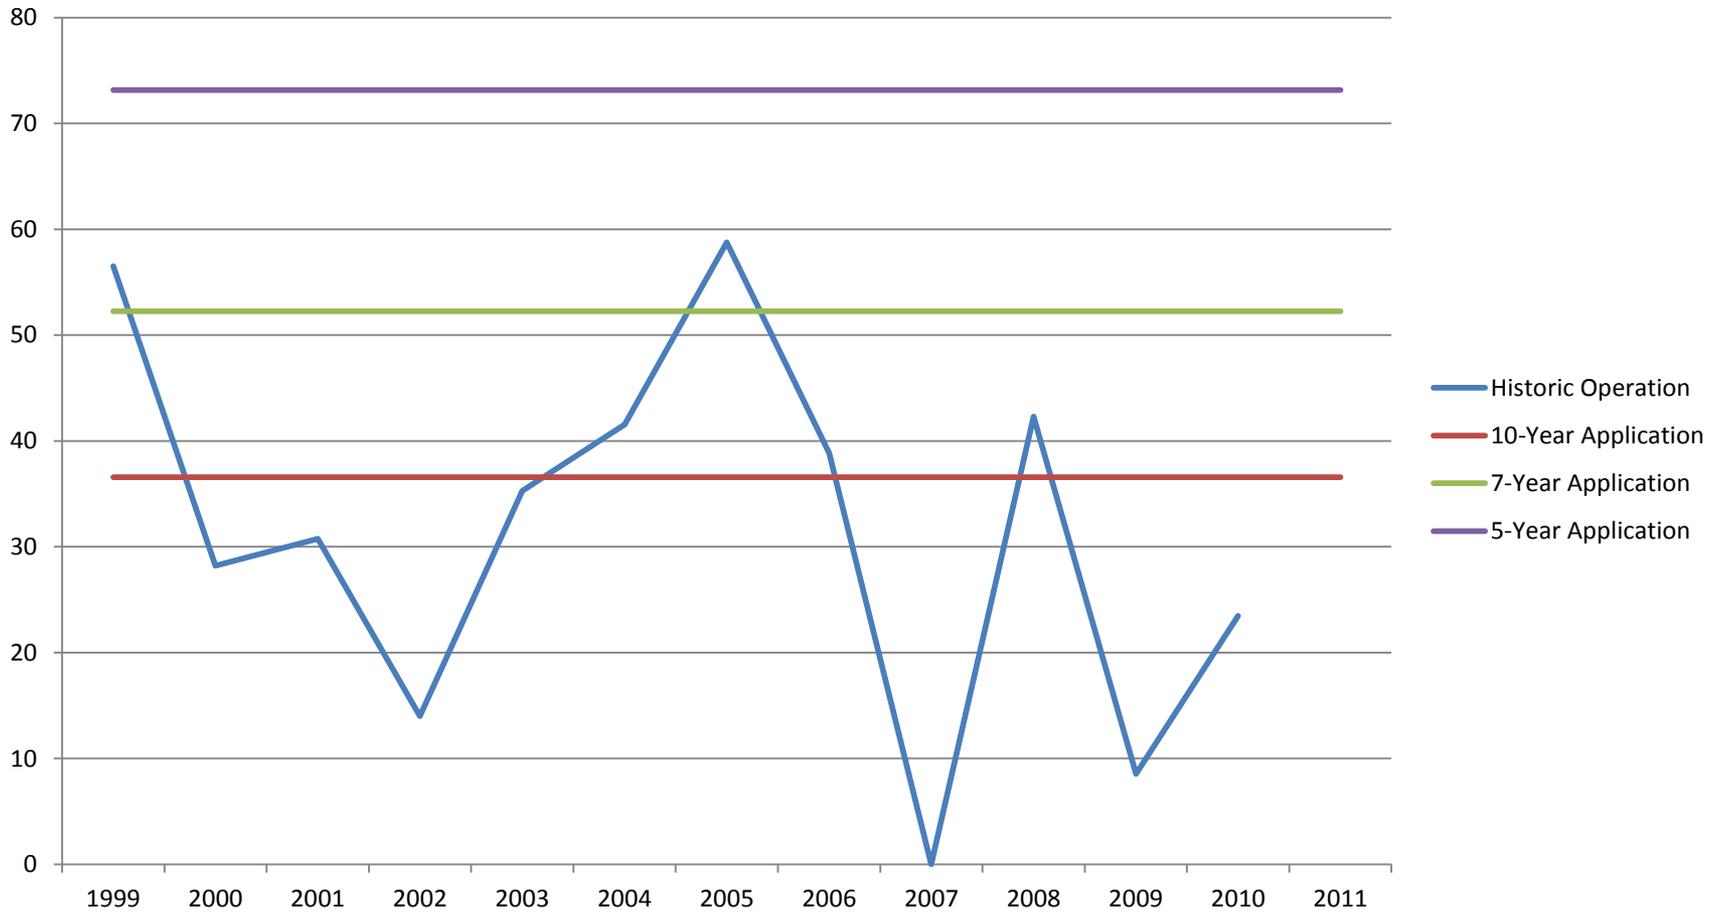
Sealcoat Application History (1999-2010)

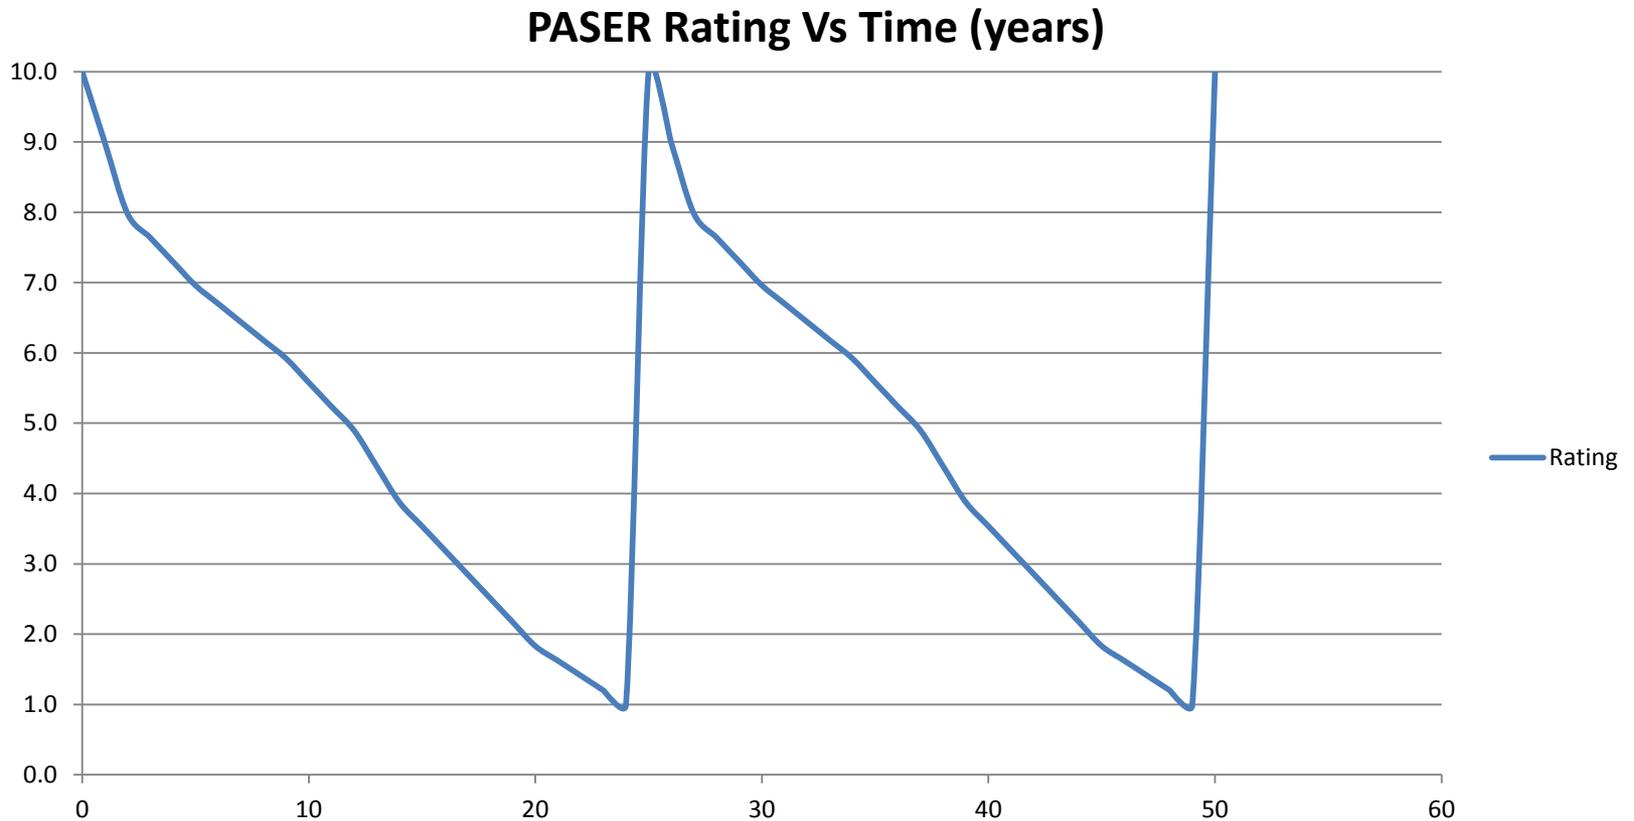
LIFE CYCLE OF AN ASPHALT PAVEMENT (Do Nothing Approach)
